Successful Pond Profile – Noble County

November 2018

Marley Beem

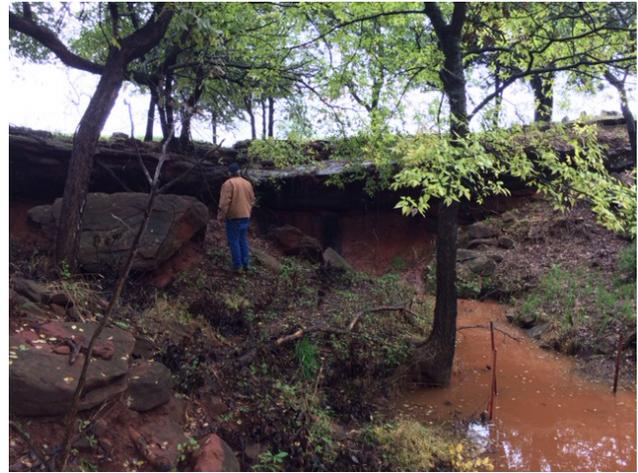
A small spring feeds into the pond, but the main source of water is runoff. Some muddiness coming off a section line road can be seen, following a 1 ½-inch rain. The long neck of the basin and the water plants in it allow for settling the muddiness out before it reaches the basin.

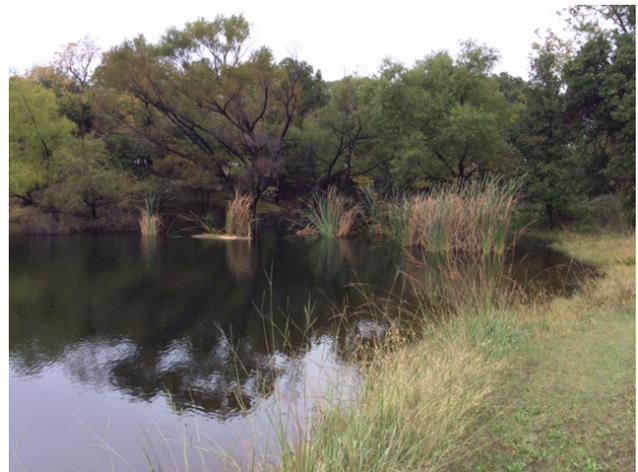
In the past, a small berm impounded spring and runoff water for livestock. Today the berm is submerged and a few cattails can be seen growing on it.

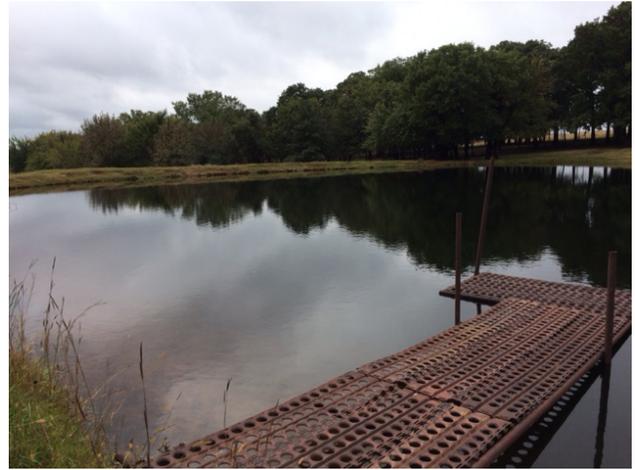
Docks are a great feature for angling. Affordable and durable materials are used to good effect in this one.
